Technical Communication 04122 :

A series of connectors for PCD1/PCD2 require more force than usual to be plugged in and out

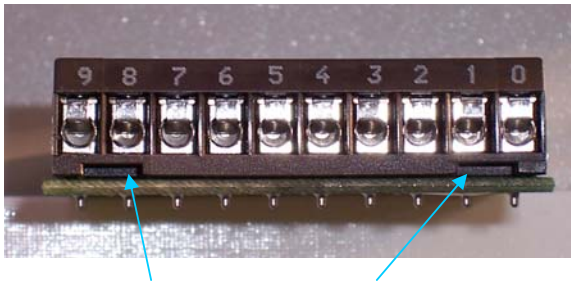
During November 2004 a series of connectors for PCD1/PCD2 were used in production, that require more force to be plugged on or removed from the board than usual.

place the screwdriver here to remove the connector from the board

- all connectors that have been delivered in November ensure a good electrical contact, so no replacement is necessary to ensure proper operation
- connectors that require more force can be removed using a screw driver as a lever
